Consumer Product Pre-Shipment Report

Moradabad Homeware Works

Moradabad · 4 Nov 2026

Client	Homecrest Retail Sourcing
Report number	GIS/RPT/2026/0026
Job reference	GIS/CP/2026/1040
Client reference	CLM-64505
Status	Issued

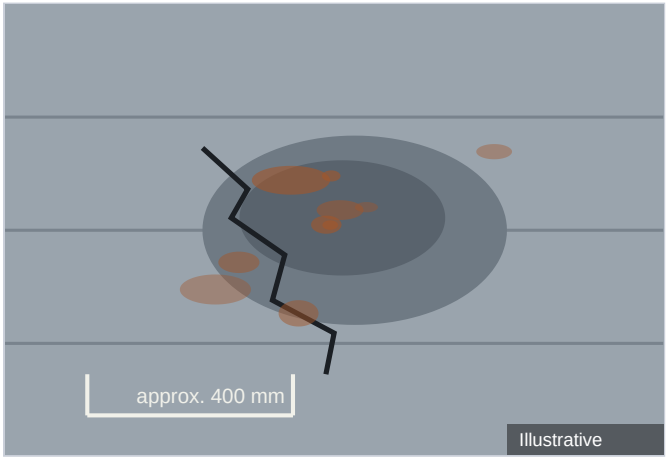
#	Defect	Class	Quantity	Remarks
1	Coating chip on body, larger than 2 mm	Major	2	Blue colourway
2	Lid thread stiff, does not close by hand	Major	2	Reworked lot, see remarks
3	Light scratch on base	Minor	5	Not visible in normal use
4	Logo print slightly off centre	Minor	3	Within 2 mm
5	Gift box corner crushed	Minor	1	Outer carton sound

Photograph 1: Coating chip on body, blue colourway

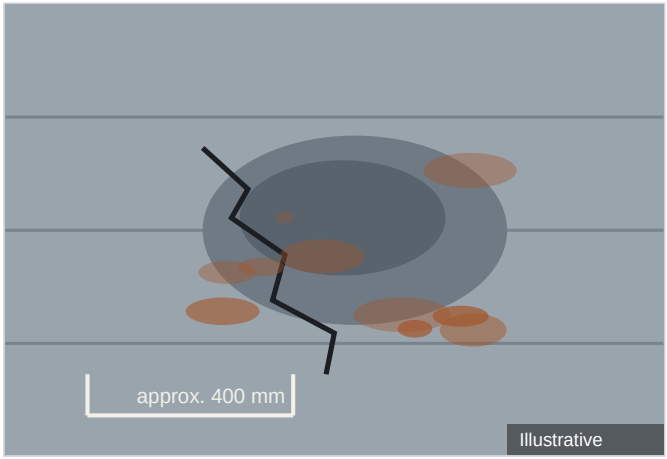
Photograph 2: Crushed corner on gift box

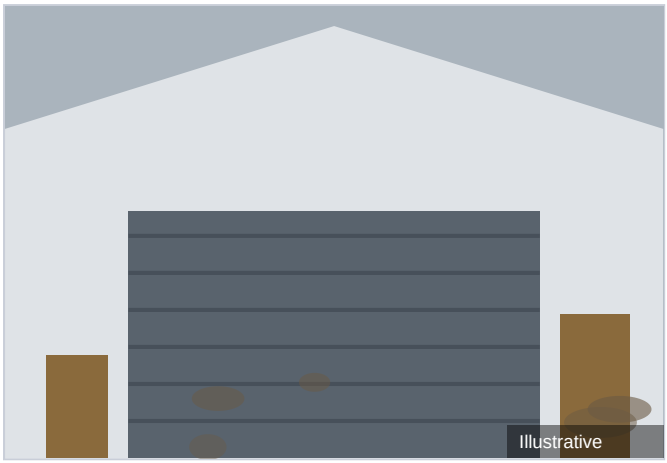
Quantity. Cartons were counted against the packing list. All 500 cartons were present, each holding 24 pieces.

Photograph 3: Packed cartons presented for inspection

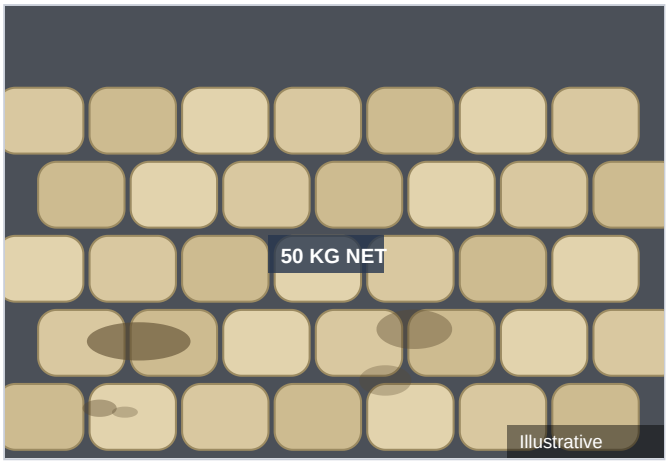
Sampling. Cartons were selected across the stack, including top, middle and bottom tiers, and the sample was drawn evenly across the three colourways.

Photograph 4: Cartons selected for opening

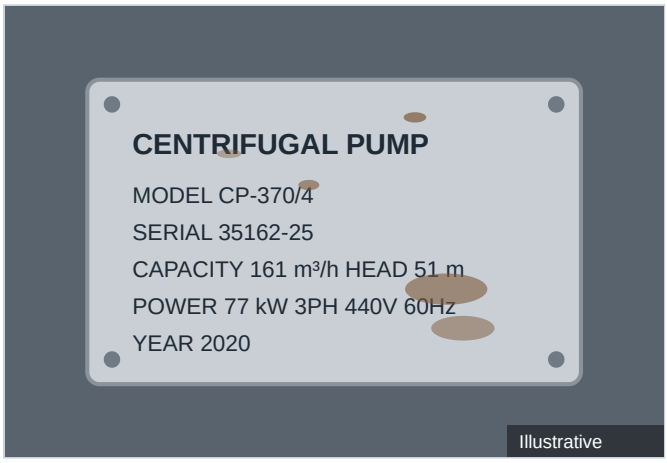
Photograph 5: Shipping mark and barcode label on outer carton

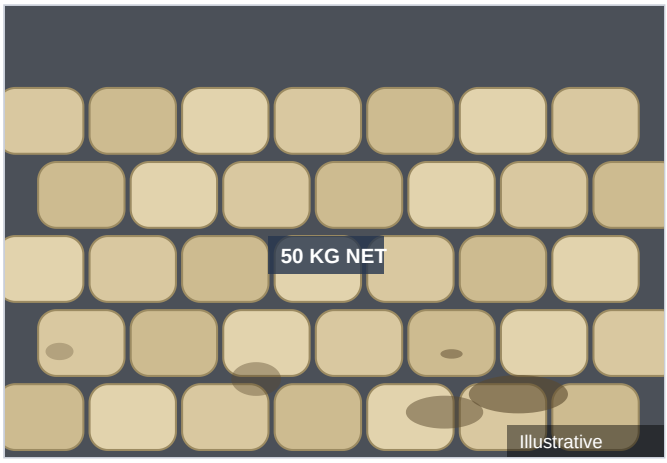
Photograph 6: Sample units laid out by colourway
